Manhole Inspection Summary

Manhole # S25GG_064MH

Location Address: **575 BRUNT ST**

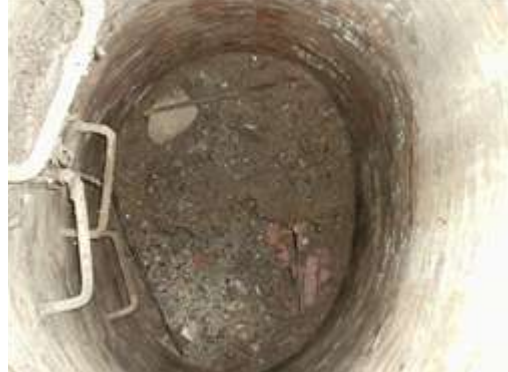
Top View

Corroded steps. Channel debris.

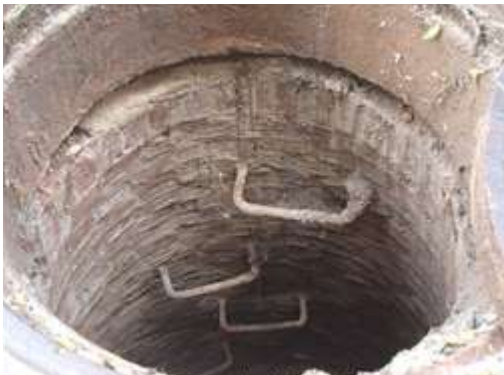
Defect

Frame leaks. Frame offset. Adjustment deterioration, loose brick and infiltration. Barrel infiltration.

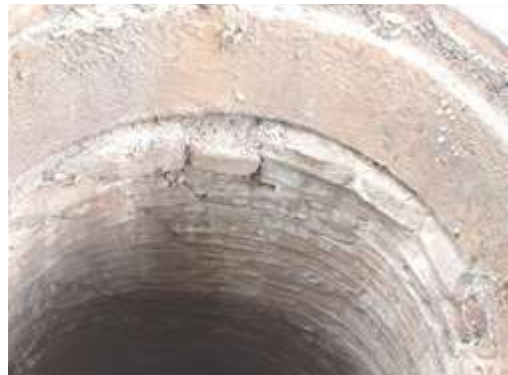
Defect

Frame leaks. Frame offset. Adjustment deterioration, loose brick and infiltration. Barrel infiltration - other side.

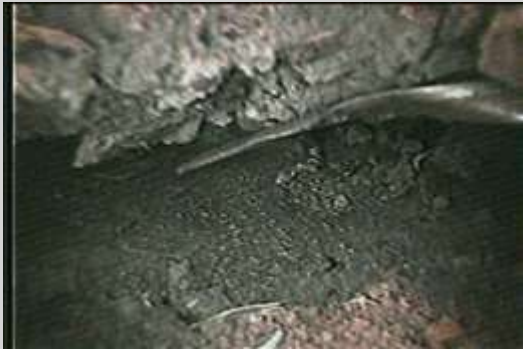
8 in. Circular Gravity Sewer
Pipe Out @ 12 O'Clock

Comments **The O12 pipe is covered with mud/debris.**

Deposits: ☐ None ☐ Mud ☐ Sludge ☒ **Debris** ☐ Grease

Silt Depth: **6** (in.) Deposits Extent: **Heavy**
